**Geneva Foundation and  
International Committee of the Red Cross**

**Basra Water Supply during the War on Iraq<sup>1</sup>**

**June 2003**

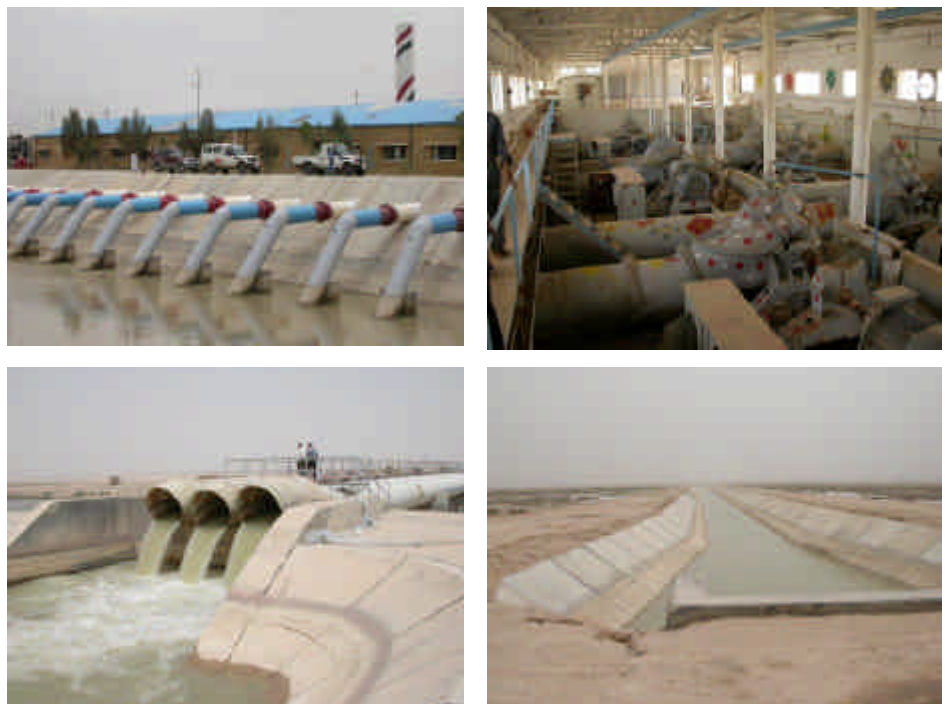
At PS2, a similar set-up is installed. 14 electrical powered pumps and five diesel pumps, each with a flow rate of  $1\text{m}^3/\text{s}$ , pump the water to cross the Saddam river and to reach its final destination at R-zero, where a complex system of “chicanes” enhances the sedimentation of the suspended solids.

**Figure 3 a,b,c,d:**  
Intake at PS2, diesel and electrical pumps, pipeline over the Saddam river and open channel to R-zero. The low output is easy to observe (20-04) close to  $1.5\text{m}^3/\text{s}$  and the consequent low level of the water in the channel is also visible

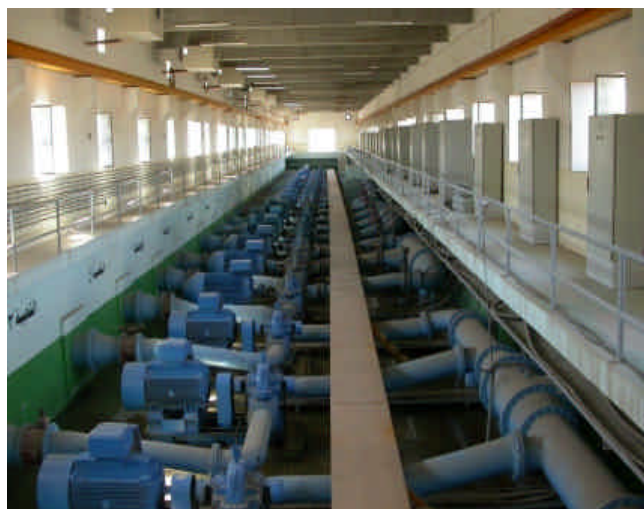
The raw water is then pumped to the different stations with an impressive series of electrical pumps. The following figure shows the main pumping assembly.

**Figure 4:** High lift pumps room at Wafa el Qaeda (R-zero)

The operation of this pumping station is essential to supply the treatment stations with raw water. Nevertheless, in case of problems, as these stations were previously pumping raw water from the Shatt el Arab, their reconnection to their source of raw water would have allowed them to operate almost at their nominal capacity. In fact, poor maintenance and repairs, not really considered essential in normal times, led to a significant decrease of the possibility to pump from the Shatt el Arab. Raw water is also supplied from Wafa al Qaeda via three other transmission lines to Khor el Zubair and Abu Kasib and to Shuaiba with treated water, through the 26 CU. From these units treated water is also pumped to the city.

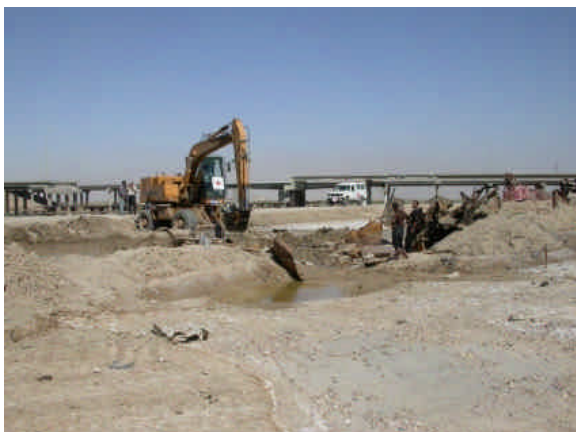
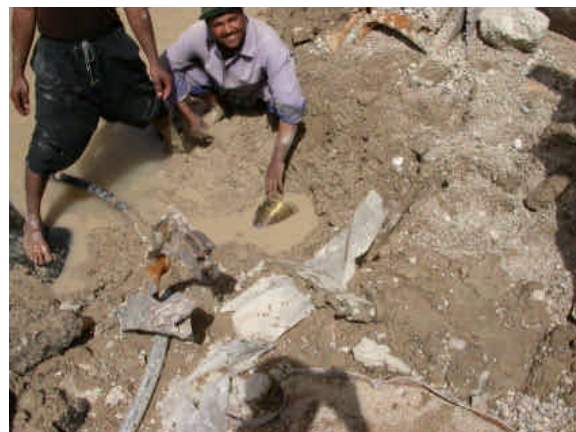
We have already outlined the potential problems identified with the supply of raw water through the Garraf/ Nassiriyah/Basrah channel and those related to the power supply of the R zero station (Wafa al Qaeda). Water is then pumped from Wafa al Qaeda to the different transmission lines. In principle, transmission lines should not be affected by the conduct of the hostilities, unless they are located in strategic locations, prone to be heavily shelled. Also damage is observed when they are located on the frontlines. Unfortunately, it is almost impossible to anticipate where such damage may occur. Some strategic locations may be more affected, like bridges, airports or transmission lines close to defence positions. In the particular case of Basrah, direct damage due to the hostilities was observed close to the airport highway bridge, on both sides of the Saddam river.

**Figure 6 a, b:** Damage and repairs on the transmission lines and problems due to UXOs

Despite the intense fighting, leaks were limited, only visible when the water was pumped into the lines and when surveys could be carried out. For instance, a major leak was observed on the raw water transmission line to Abu Kasib (1000mm diameter). Repairs carried out in such locations must be done with the necessary precautions, as UXOs<sup>1</sup> may be present. Repairs at one of these locations had to be interrupted due to the discovery of a 150mm shell, probably unexploded. Clearing was done manually in one day by “skilled civilians” who were attracted by the relatively high value of the metal, close to 6,000 I.D. per shell (2.5 USD at the exchange rate of 1 USD = 2000 I.D. prevailing end of April). The repair was completed successfully the next day by an ICRC contractor, allowing the resumption of the pumping to most of the Abu Kasib stations, temporarily supplied from the Shatt el Arab. Leaks in the raw water transmission lines may be problematic for several reasons. Less water will reach the WTSS and people may use water unfit for consumption, as its taste is better than the treated one, particularly if the WTSS will have to revert to the Shatt el Arab and blend the raw water to maintain its output.

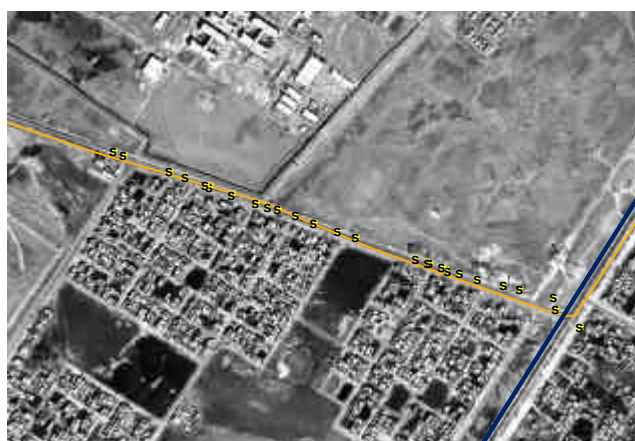
An example of such damage is shown in the next figure where the observable leaks on the raw water pipeline supplying the Bradiyah WTS have been collected using a GPS and mapped. In this particular case repairs would have been easy if an alternative source would be available to cope with the needs of the people living in this area, probably poorly supplied with treated water. Decreasing the quantities of water reaching the Bradiyah station is, however, decreasing the amounts which would be pumped into the network.

**Figure 7:** Leaks observed on the raw water pipeline supplying Bradiyah WTS from Wafa al Qaeda. Not yet repaired on 10.05.03.

The losses and the consequent damage are most likely to continue until normal functioning of the network will guarantee the supply to the temporarily deprived areas. It is therefore essential to improve the supply of raw water to normal values and to avoid any drastic decrease of the amounts delivered from R zero to all the stations.

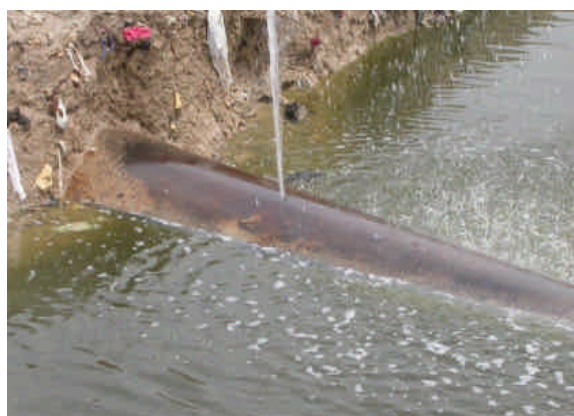
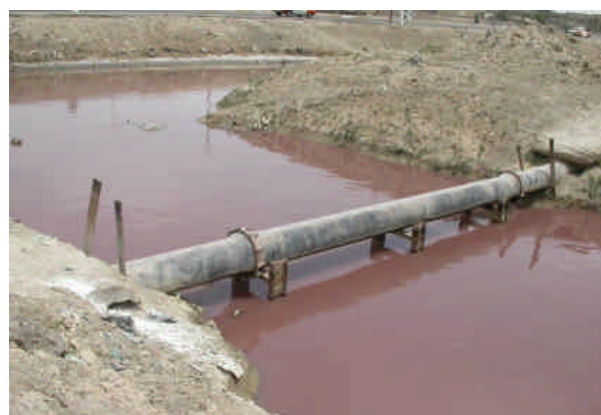
Other locations are prone to be damaged. In Basrah, the pipelines are quite visible where they are crossing the relatively complex network of canals or where they cross under the bridges. These locations would have been particularly at risk and one would have expected many makeshift connections or direct punching.

**Figure 8 a, b:** Canal crossing where damage may be easy, but also easy to spot

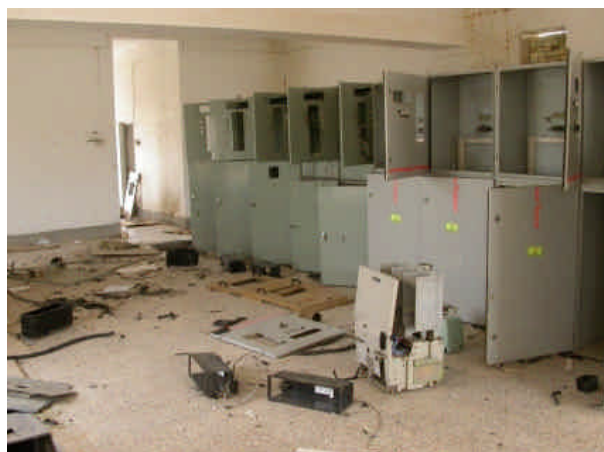
**Figure 9:** Damage by looters at the circuit breakers transformers control boards at PS2

But the main damage has been done on the circuit breakers and control boards of the transforming units. Isolation oil was also drained from the transformer, which was relatively a minor problem. More difficult to assess was the damage done to the SP3 sub-station, essential to supply electricity to PS2, in order to restore its normal functioning. Looters were active for a while as no protection was granted to these premises, until very late, when a special police force was finally created, at the beginning of May 2003. When some units were eventually dispatched to these locations, the damage was too important for a quick repair.

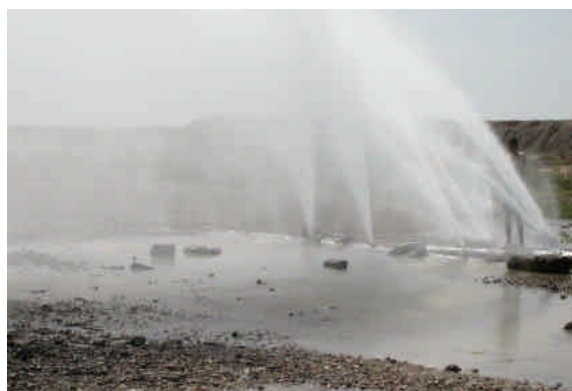
The problems of the transmission lines have been outlined before and any leak in these high sections pipelines must be repaired immediately. Important leaks like the one shown in the next figure, on the treated water pipeline to Shuaiba were observed and repaired only when the pressure in the pipeline was important. These leaks too can be easily repaired by a team specifically in charge of the large pipelines and equipped with the necessary tools to carry out the job. Other “minor leaks” are more difficult to spot.

**Figure 13:** Leaks at the treated water pipeline to Al Shuaiba

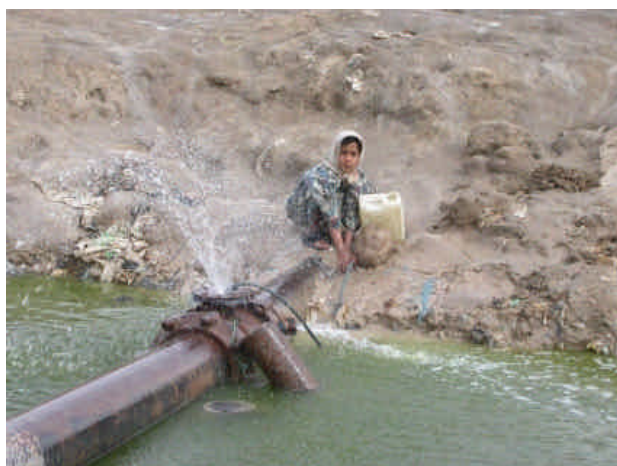
**Figure 14 a:** Air valve leak on a primary network pipe

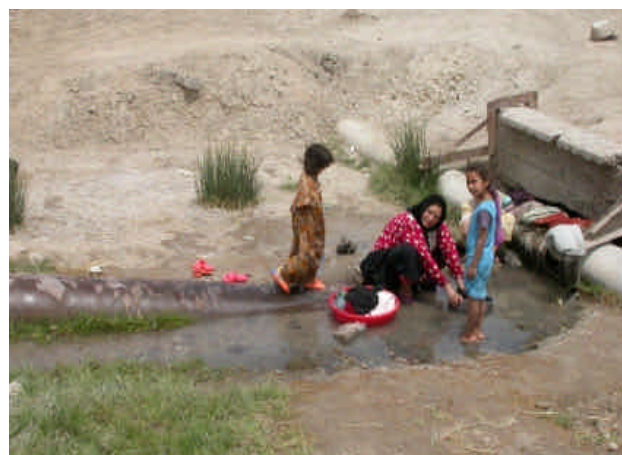
**Figure 14 b:** Water from leaks on a transmission line

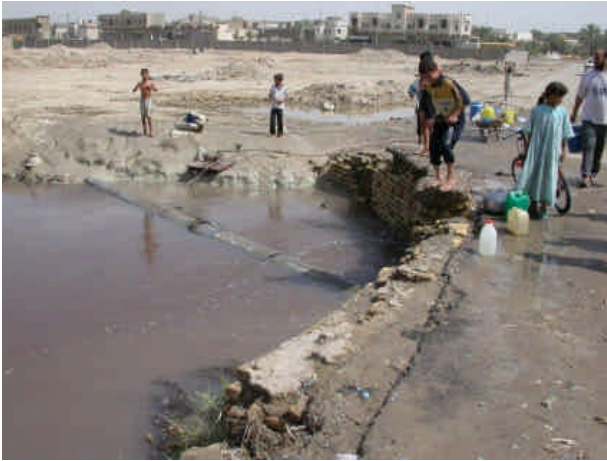
This pipe (asbestos cement 300mm diameter) is located behind the general hospital. It has been repaired on several occasions, (7 times on 10 May) but was broken almost immediately. As it can be seen, pressure is high but

**Figure 14 c:** Broken AC pipe (General Hospital)

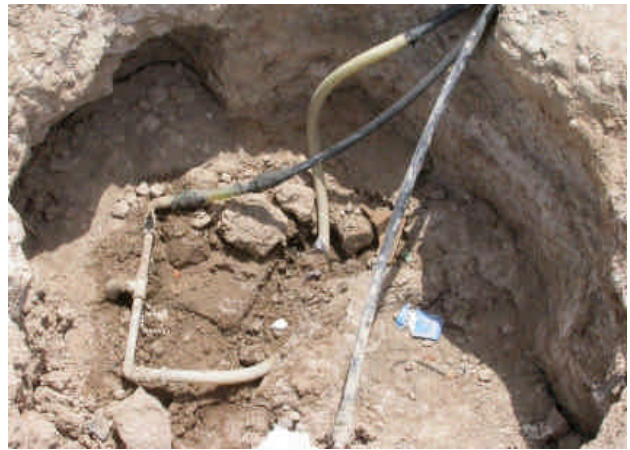
**Figure 14 d:** Illegal tapping on a secondary line

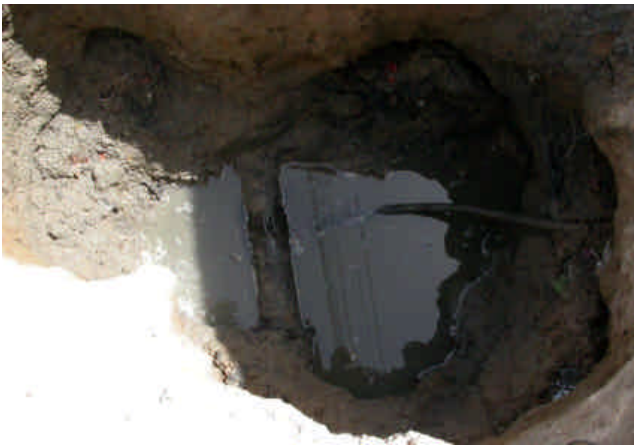
**Figure 14 e:** Poor collar connection

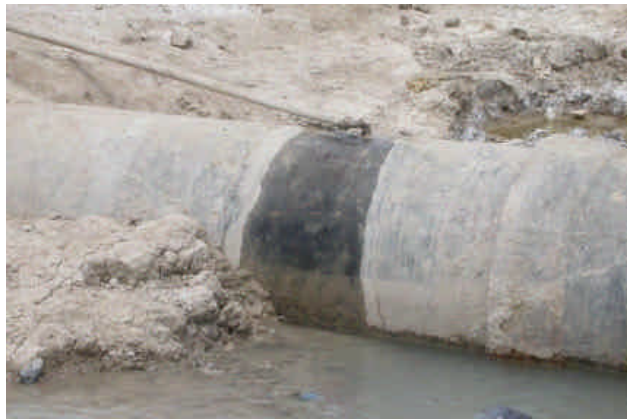
**Figure 14 f:** Tapping on a transmission line

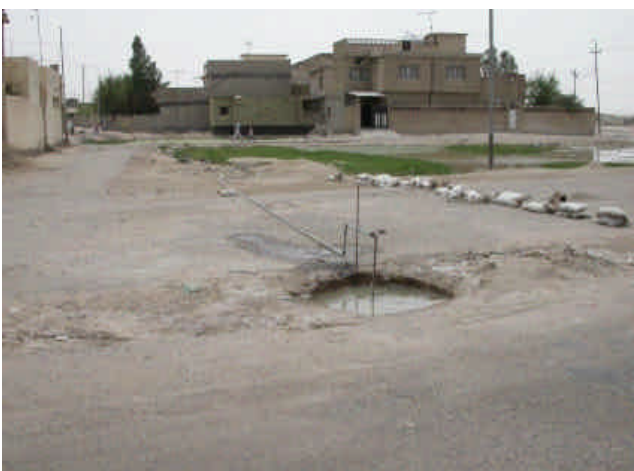
**Figure 14 g:** House connection

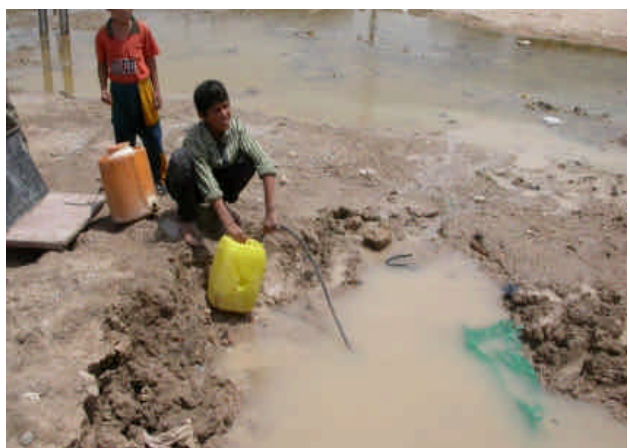
**Figure 14 h:** Poor tapping in mains

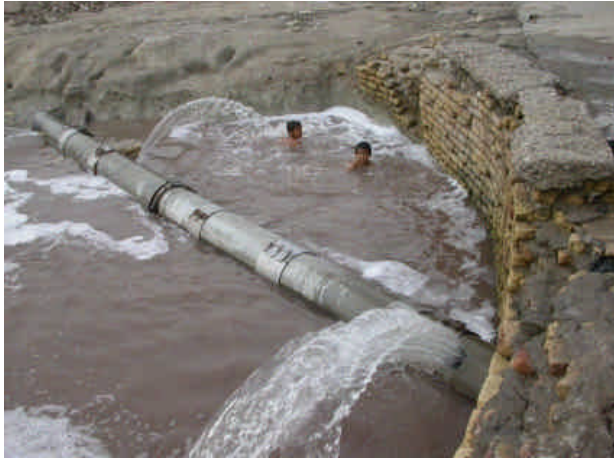
**Figure 15:** Leaks in the asbestos-cement pipe behind the General Hospital

it will certainly result in poor pressure at other locations of the network, due to these important losses. A safer solution will have to be found, and eventually a device to allow people to fetch water, without creating further damage. The problem here is not only due to effect on pressure but also to the possible cross-contamination in case of pressure decrease, as the pipe is in close contact with sewage water. Sooner or later the contamination will most likely occur and the network will have to be flushed and then disinfected with important levels of residual chlorine for several days, until one is sure that any possible health related illness is combated.

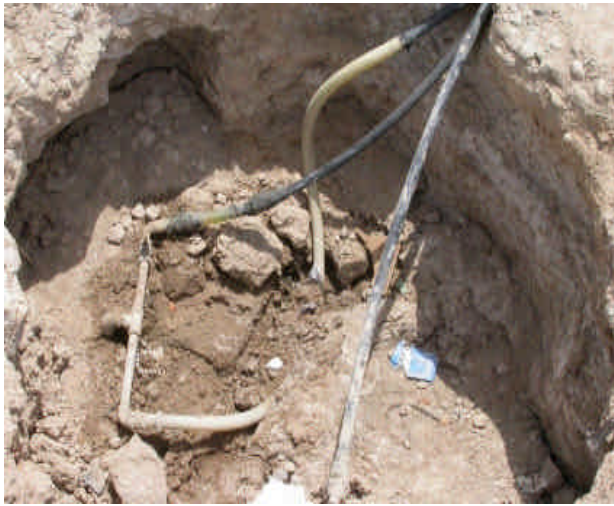
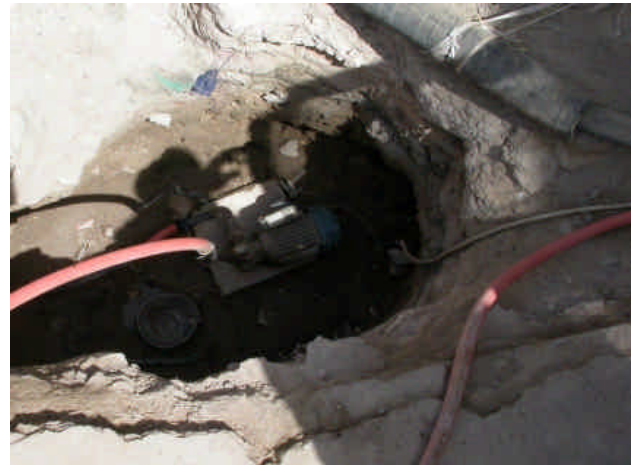
Of increased concern, were other professional connections like the one shown in the next figure, where the raw water pipeline supplying Bradiyah, was connected using a 100mm pipe (4 inches) to the treated water

**Figure 17 a, b:** Makeshift “professional” illegal connection or pump tapping

distributed from the station and then tapped at several locations. It appears that the collars were located after the branch to take advantage from the better pressure due to the transmission line, disregarding the contamination problem. Unfortunately, customers located down flow may not be aware of the problem and would certainly be affected by any water borne disease carried in the raw water. It is not clear when such a system was installed, but what is clear is that it will have to be removed.

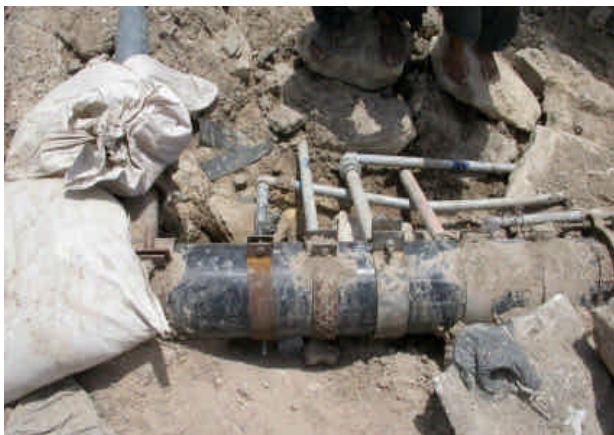
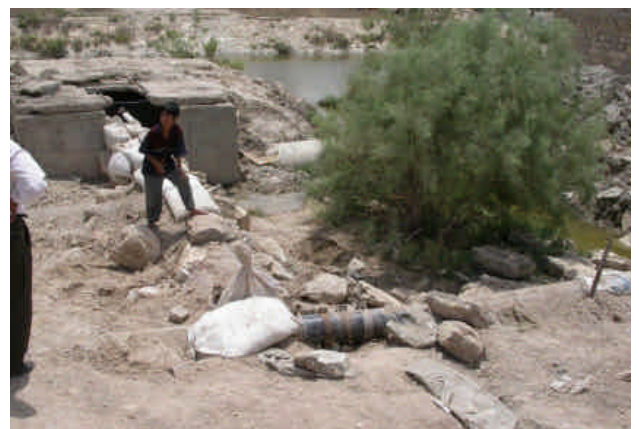
**Figure 18 a, b:** Illegal branching and connection, to be removed

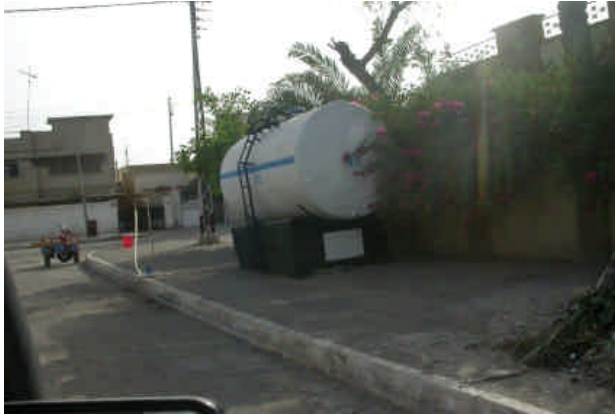
**Figure 20:** Reverse Osmosis (RO) water selling point

At the beginning of May, the tankers were allowed to refill at the Petrochemical Factory (south of Al Zubair) where RO water was available in large quantities, up to 450m<sup>3</sup>/h. Agreements were also signed with the RO units installed by the UERCS (United Emirates Red Crescent Society) within the Al Rebat station. Their production was fairly limited, up to 45m<sup>3</sup>/d but was very useful in case of emergency.

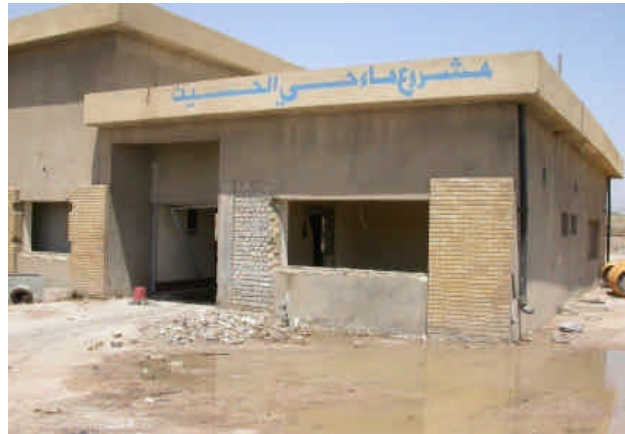
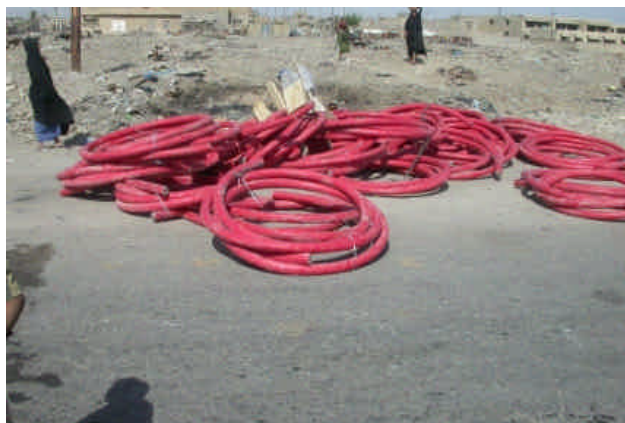
Other premises, like the Al Hay Hussein booster station, located within the Al Hayyanniyah suburb, were damaged to a point that they would have to be re-equipped completely, with all the electrical boards looted, and with some pumps and all the window frames removed.

**Figures 25 a,b:** Al Hussain booster station and cables prepared to be sold

This station was pumping treated water (ex Al Bradiyah or Aqua 25) to the small town of Al Zubair, located South-West of Basrah. As a consequence, 5,000 families will have to be supplied by tankers until it is possible to repair it, which will certainly take months, owing to the damage made.

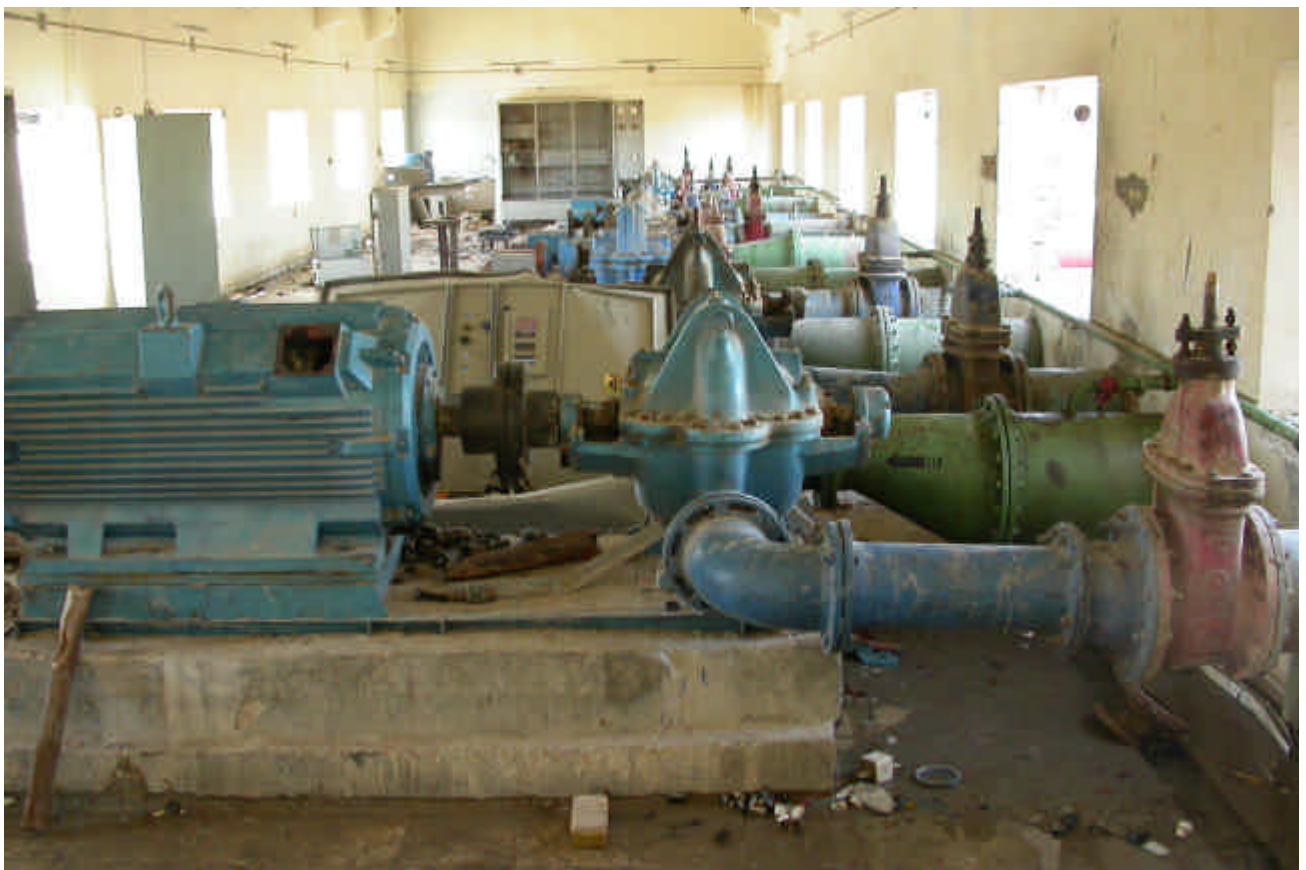
**Figures 26:** Al Husai booster station after looting
