# Dili (East Timor) Re-establishing the water supply after the events of September 1999

*P. Jansen, J. Jones, P. Kilchenmann, V. Meilhaut, D. Schmid, M. Weiersmueller<sup>1</sup>*

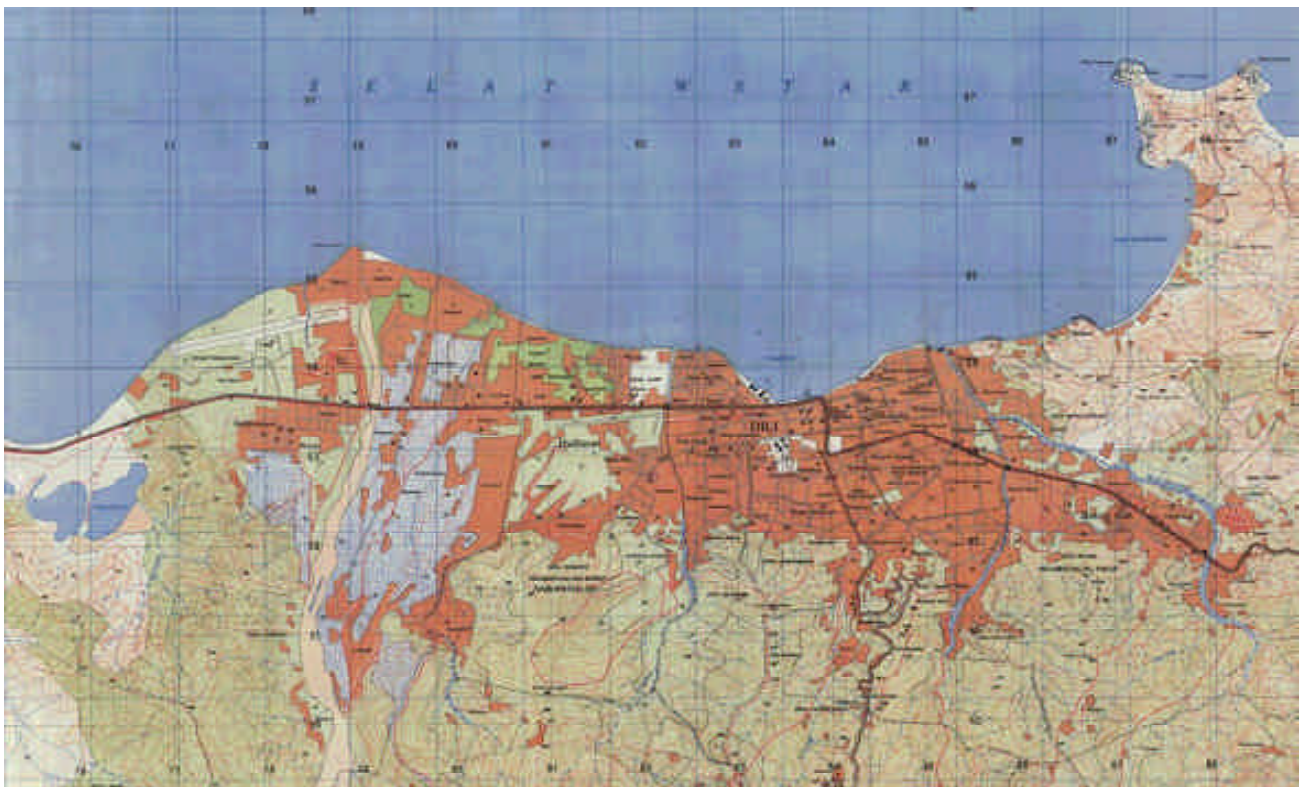
Figure 1 is a topographic map of the city<sup>3</sup> showing the urban areas and the limits of the districts. This map has been used to generate the 3D model shown below and to georeference the recent mosaic obtained from

*Figure 1*  
*Topographic map of the town of Dili*

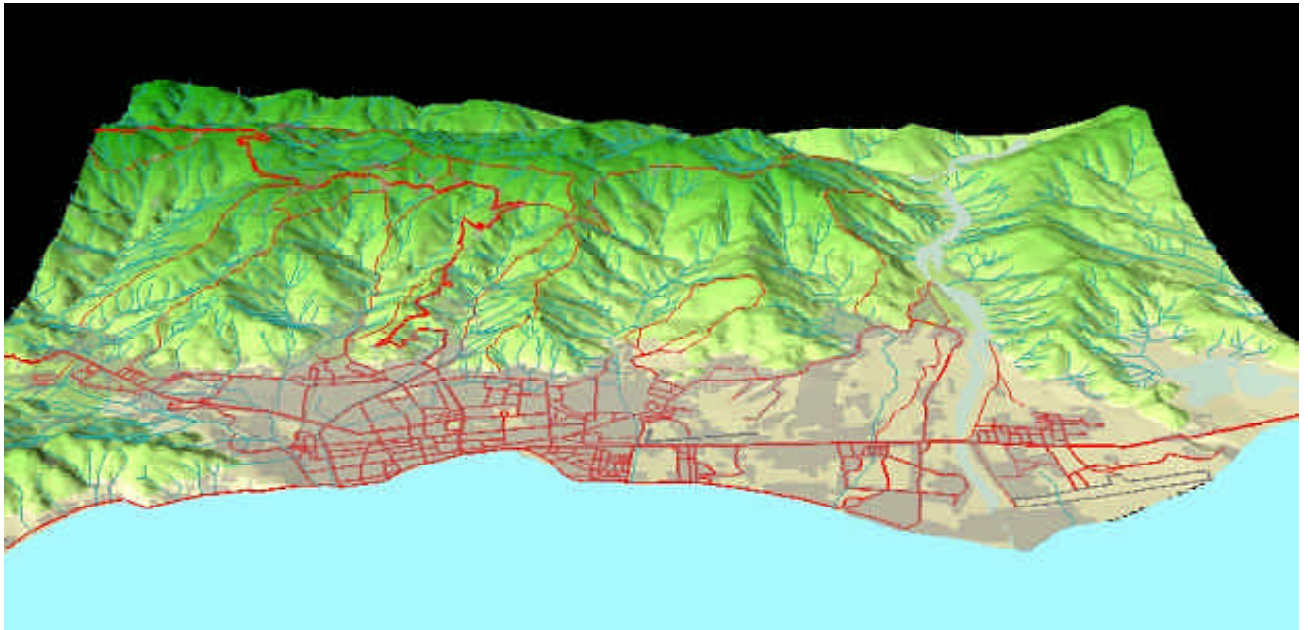
*Figure 3*  
Topographic 3D model of the city showing the main rivers and the location of the main water production facilities
