### **Kabul water supply: evolution since the 1992-94 civil war**

**Occasional paper No. 7**

**October 2002**

# Kabul Water Supply: Evolution since the 1992-94 Civil War

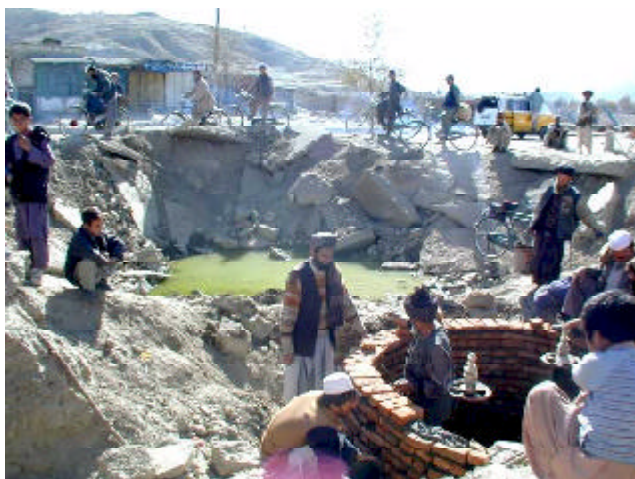
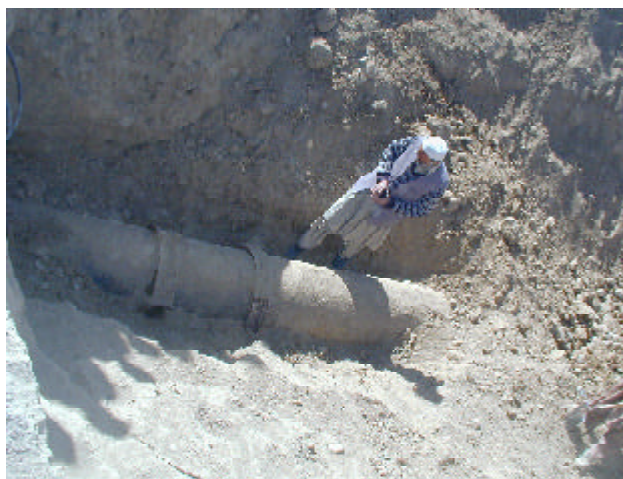
**Figures 9 & 10** Damage to the distribution line at the main road leading to Micro-rayon apartment complex and to the 600 mm asbestos/asphalt coated cast iron pipe at the Ghazni road and makeshift repairs (November 2001/P.G Nembrini).

The main consequences of the destruction of the pipes was the interruption of the distribution of water from the Afshar well field to the Kheir Khana area (350,000 inhabitants) and the cut-off of the supply of the Micro-rayon apartment buildings, hosting an estimated 150,000 to 180,000 people. The inhabitants of Kabul could rely on alternative sources, by collecting water from hand-pumps installed by many organisations during the recent years.

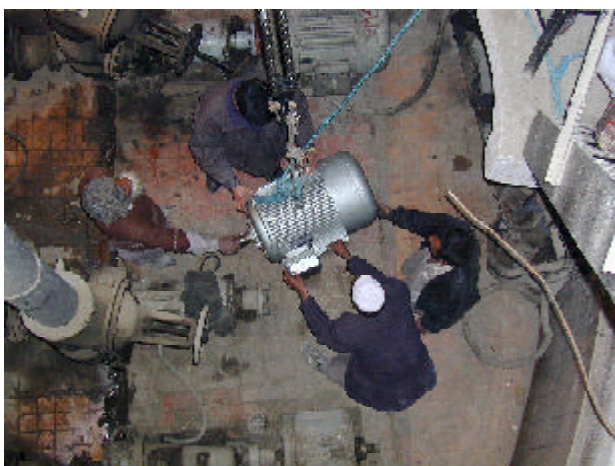
**Figure 13** Replacement of the electrical motor of one of the sewage lifting pump in Micro-rayon

situation was apparently improving even if it was too early to draw any conclusions about the sustainability of the operation. Data collected in the following weeks show that the performance of week 48 was unique. The mean daily total production fell from a maximum close of 40,000 m³/day to about 30,000 m³/day during week 49, but increased regularly in the following weeks when ordinary problems linked with the distribution of power could be solved and with the resumption of the operation of other deep wells (Debory University borehole). In the specific case of Micro-rayon apartment blocks, ICRC assisted the public maintenance department to replace or rewind several electrical motors operating the sewage lifting pumps, in order to avoid regular flooding due to the increased pumping, thus increasing the security of the whole waste water evacuation of this huge apartment complex.

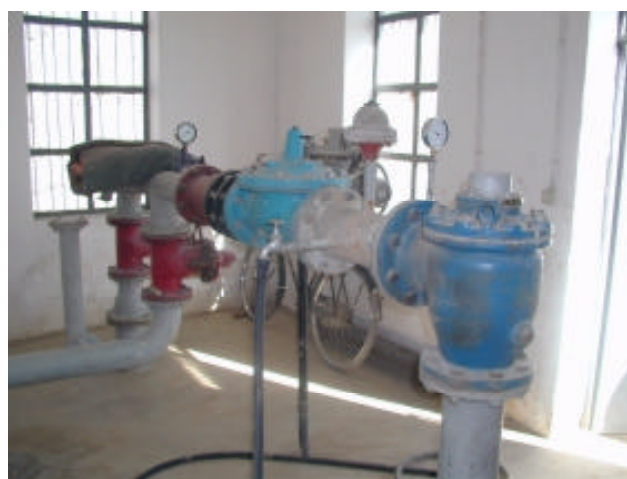
**Figure 15b** Afshar well field. Pumping Station.

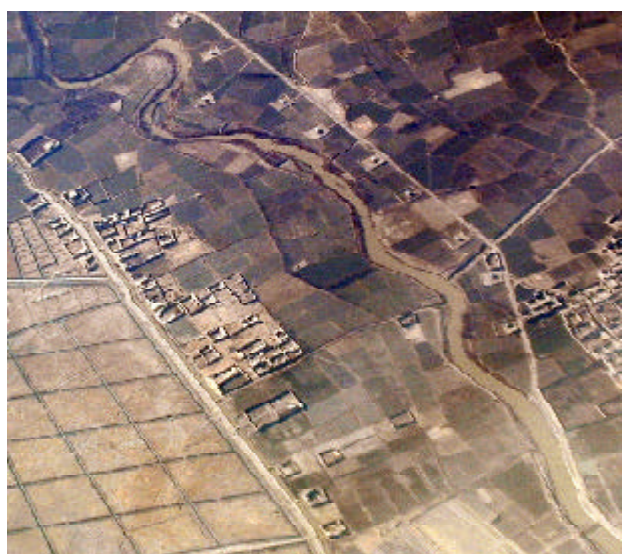
**Figure 22** Aerial view of the Logar well field, the Logar river and the 10 pumping stations (January 2002)

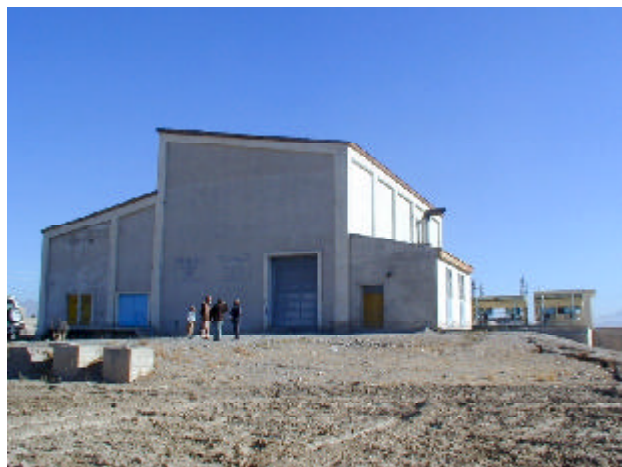
**Figure 23** Bagrami High Lift pumping Station

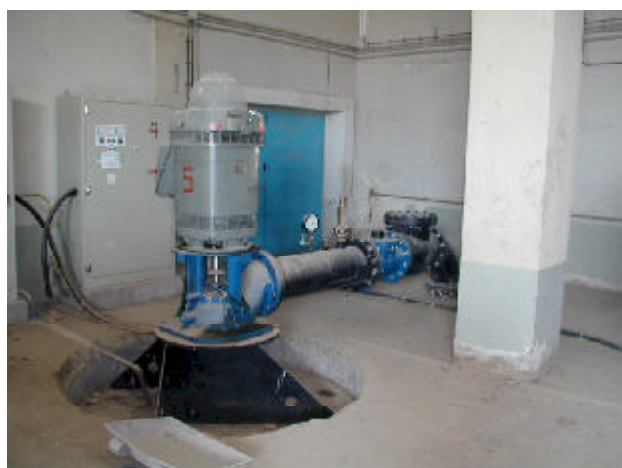
**Figure 24** High Lift pump (400 kV/ 185 kW)

At the hydraulic level, several tests have been carried out. All the pumps have been tested and found to be in working condition and in no need of capital investment.

Their output was measured and found compatible with the specifications of the supplier and a “similar and fairly constant static water was measured in all the boreholes, with a relatively small draw-down when pumping”<sup>29</sup>. It was decided that only one high lift pump would be operated at the initial stage, bearing in mind the poor state of the network. A total of 6,500 m<sup>3</sup>/10 hours would need to be produced. To avoid heavy losses in the damaged network, it was recommended to supply only two districts, D1 and D8, the first being one of the most densely populated district of the town and the second because of its high saline water, with conductivities reaching values by far higher than the admitted WHO guideline of 1,500 uS/cm<sup>30</sup>.
