# Novi Sad (Republic of Yugoslavia): How the water supply of the town was affected by the NATO campaign of 1999

P.G. Nembrini,<sup>1</sup> S. Kulacin,<sup>2</sup> R. Conti,<sup>3</sup> A. Oppliger<sup>3</sup>

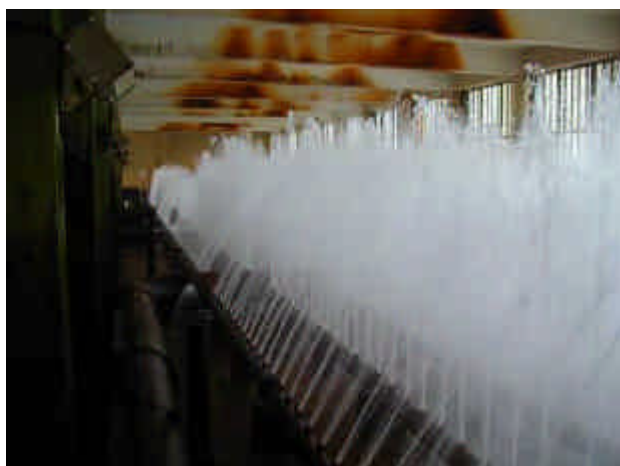
Figure 5  
Aeration room to remove iron at the WTS

Aeration is performed at the treatment station. Fe (II) is oxidised to iron (III) by atmospheric oxygen and the particulate precipitate is removed by rapid filtration. The water is then pumped into the network at a flow rate of about 2 m<sup>3</sup>/s via pipelines varying in diameter from 900 mm to 700 mm. The treated water was brought to the right bank through a 900 mm pipeline via the upstream bridge, and a 450 mm pipeline via the middle bridge. Several intermediate storage reservoirs were located on the right bank and water was pumped from them to the different localities by several booster stations. Water was then distributed by gravity from the 15,000 m<sup>3</sup> elevated storage reservoir (Institut), located at a height of 140 m, the mean elevation of the town (left bank) being about 80 m. The other storage reservoir, Transzament, with a capacity of 4,000 m<sup>3</sup>, supplied by the 450 mm pipeline via the middle bridge, is also located at an elevation of about 140 m. This reservoir was not connected to the Srem network and was used as a balancing tank for the left bank network.

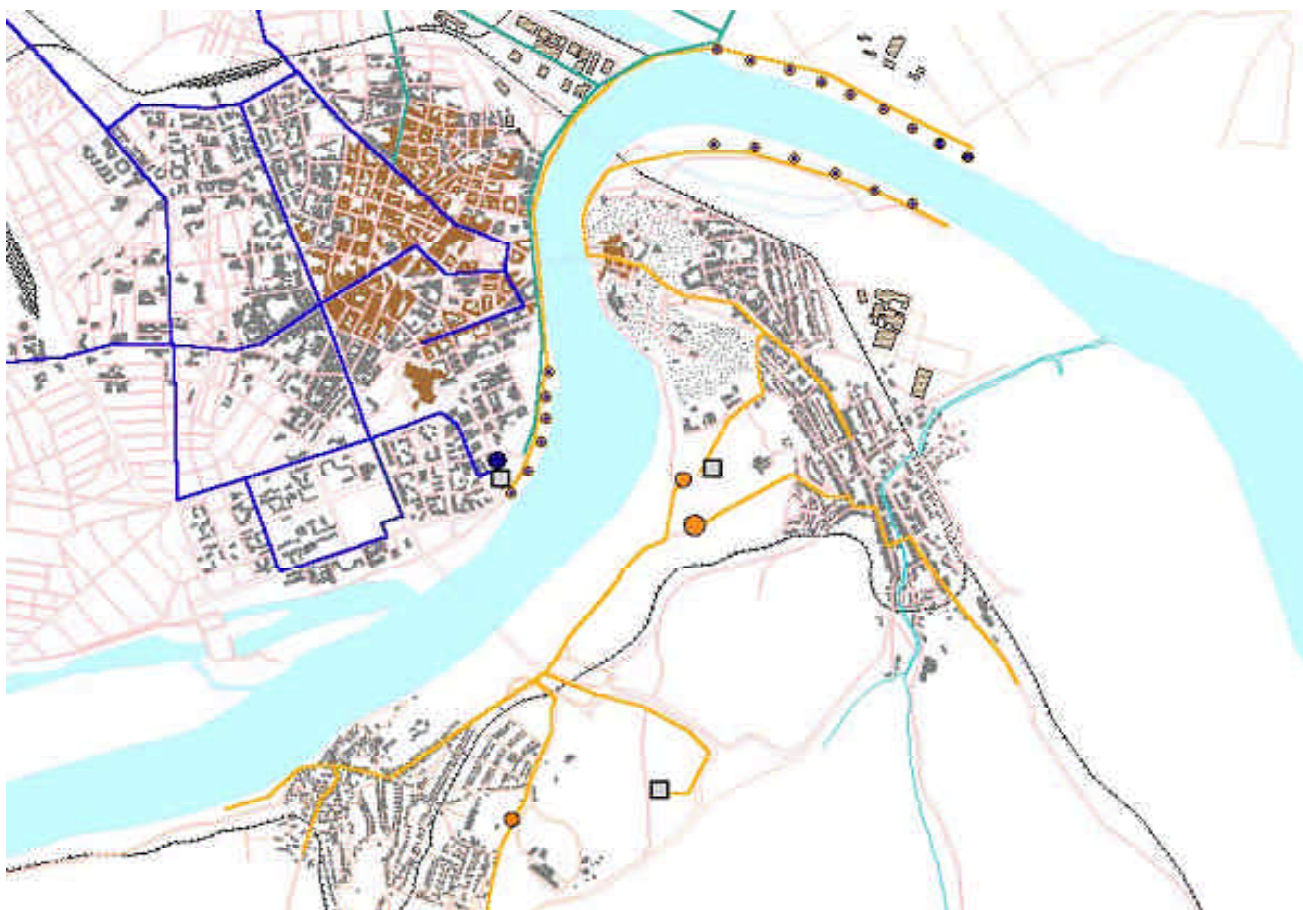
*Figure 7*  
Raw water distribution: the primary network after the destruction of the last bridge on 24 April 1999

The situation on the right bank was more serious, albeit not dramatic. Vodovod decided to connect the raw water supply line to the treated water network and to distribute untreated water for domestic use, i.e. toilet flushing, personal hygiene, cleaning and laundry, although the latter was not recommended because of staining due to the high concentration of iron. The following figure (*Figure 7*) shows the new configuration of the network, with raw water distributed throughout the right bank. Apart from the concentration of Fe (iron, up to 3-4 mg/l) and Mn (manganese, up to 0.5 mg/l) the quality of the water made such a decision possible, even if this solution had to be considered as temporary. Drinking water guidelines recommend that the concentrations of the two metals should be less than 0.3 mg/l.

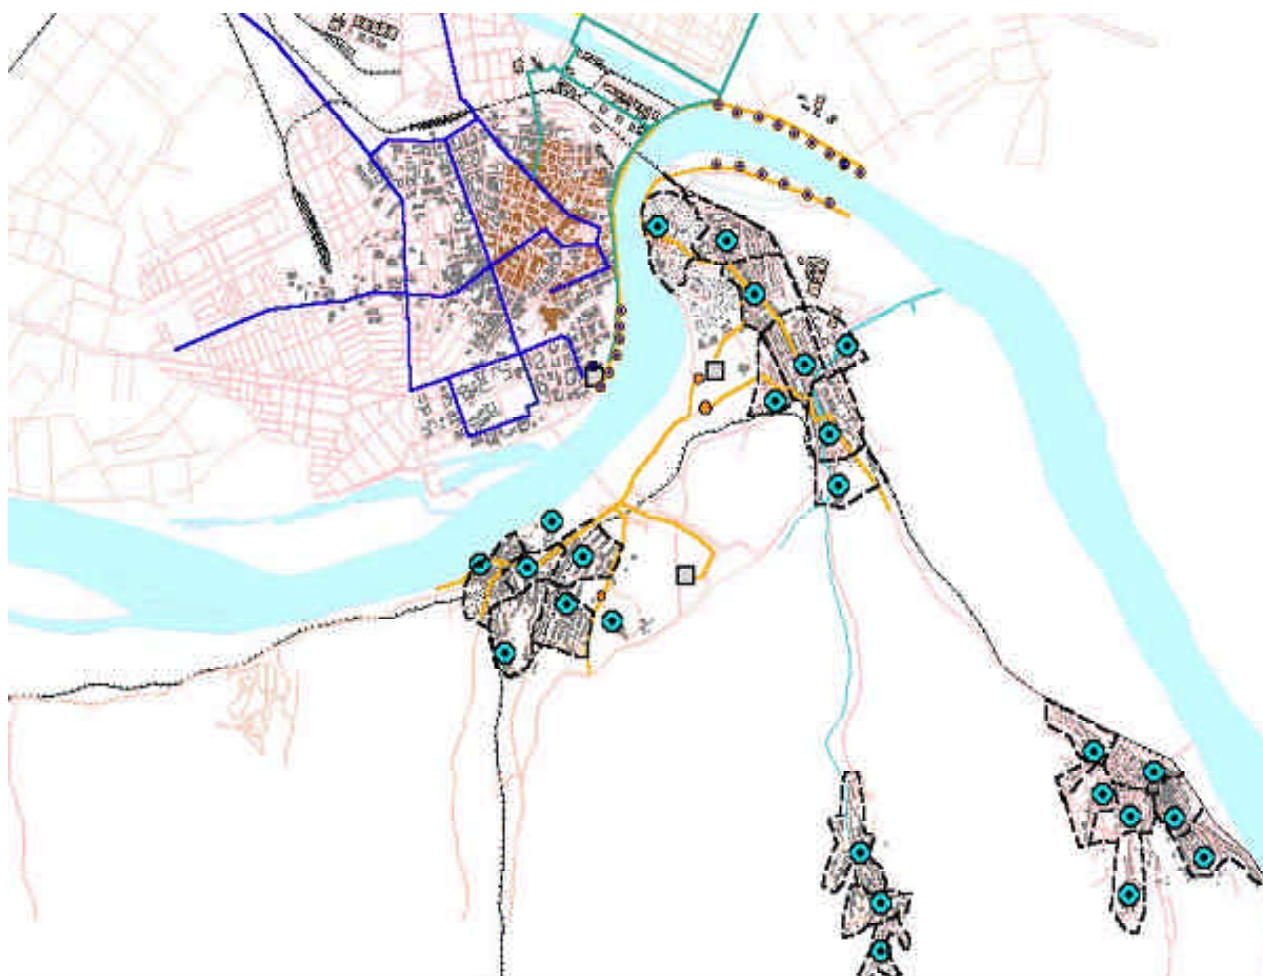
Figure 8  
Areas covered by a distribution point in four suburbs on the right bank of Novi Sad

The urbanised areas were tentatively divided into distribution areas where the 4,000 l storage tanks, equipped with distribution ramps, were to be located. A total of 22 distribution points were chosen, of which several were designated to respond to specific needs in case of overly heavy attendance at some points. The installation would have to be done gradually and would have to be stepped up according to consumption, which would have to be monitored. A transport schedule was prepared and the mileage of the trucks was to be monitored for fuel consumption control and to foresee future needs, as the distribution would last for at least three months, maybe six or more, depending on the kind of medium term solutions that would be found. The following map shows tentatively where distribution tanks were located.

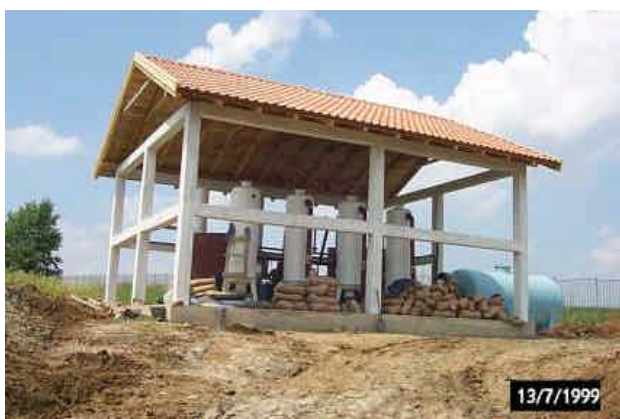
Figure 12  
Treatment unit to remove iron concentration

In order to reduce the distance travelled by the trucks and the burden on the production capacities of Beocin, two units capable of producing 10 m<sup>3</sup>/hour of potable water were built and installed in Petrovaradin and Sremski Karlovci. The units were connected to the network and used technical water to produce drinking water with an iron concentration under 0.1 mg/l. Both units were built using local expertise and supplied the tankers by gravity, through a filling gantry. On 21 July both units were operational. They were maintained in operation until the right bank was supplied from the new pipeline laid on the bottom of the river.

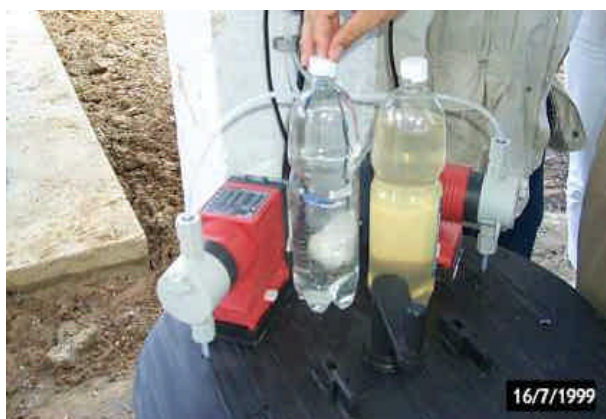
Figure 13  
Before and after iron removal

eventually stop it altogether. Removal of iron is in principle quite simple and only requires aeration to oxidise iron (II) to iron (III), followed by filtration. The only problem was that such compact units were not available in the market and would have to be designed specifically. Normal compact units remove suspended solids with the addition of a coagulant (aluminium), followed by filtration, but are not specifically designed to remove iron.

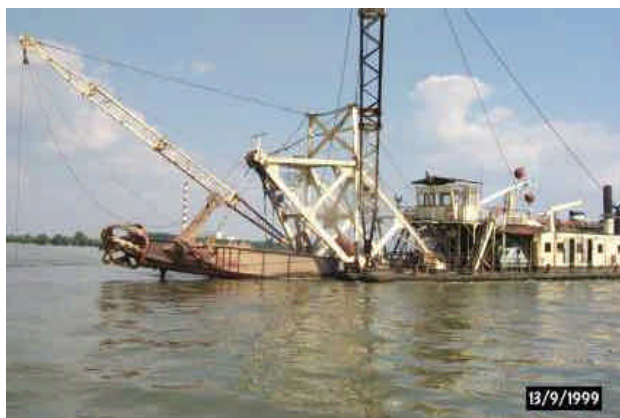
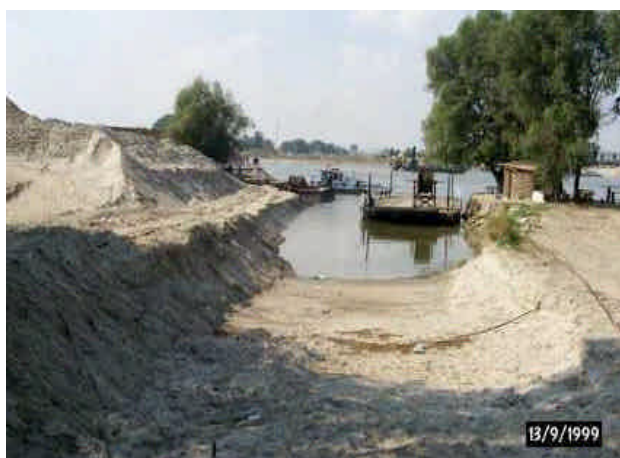
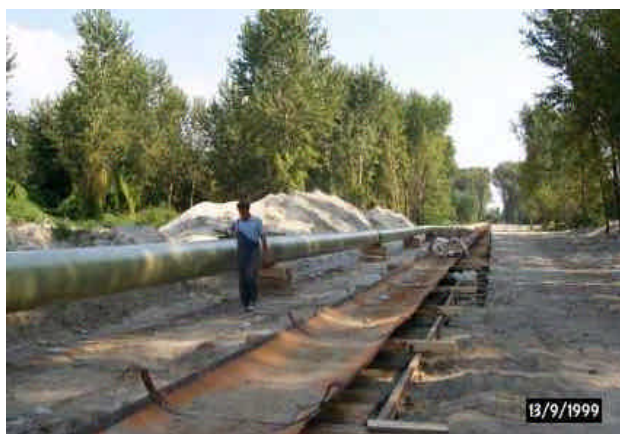
When the hostilities ended, it was not clear when and where the bridges would be rebuilt. In order to create a more permanent solution for the town's water supply, the authorities decided in July to build a pipeline across the Danube. The initial project was abandoned and a new location and a new laying technique were chosen. Two fibreglass pipes 500 mm in diameter were pre-assembled perpendicular to the shores, laid over a metallic support and maintained in position with the use of sandbags. The whole assembly was then pulled into

Figure 14 - 16  
Dredging the underwater canal and the shores. Preparing the pipeline assembly

the river where a channel was dredged. Finally, stones were placed over the sandbags to maintain the whole system in position and to insure a minimum of protection. One pipeline was meant for raw water and the other to pump drinking water and resume the normal supply to the right bank. The whole operation was completed by the end of October. Several problems had to be solved: one of the pipes was damaged during construction and had to be repaired. Despite the intervention it was never possible to pressurise it again up to the required 7 bars. It was then irrevocably damaged by an anchor, and its use had to be discontinued.

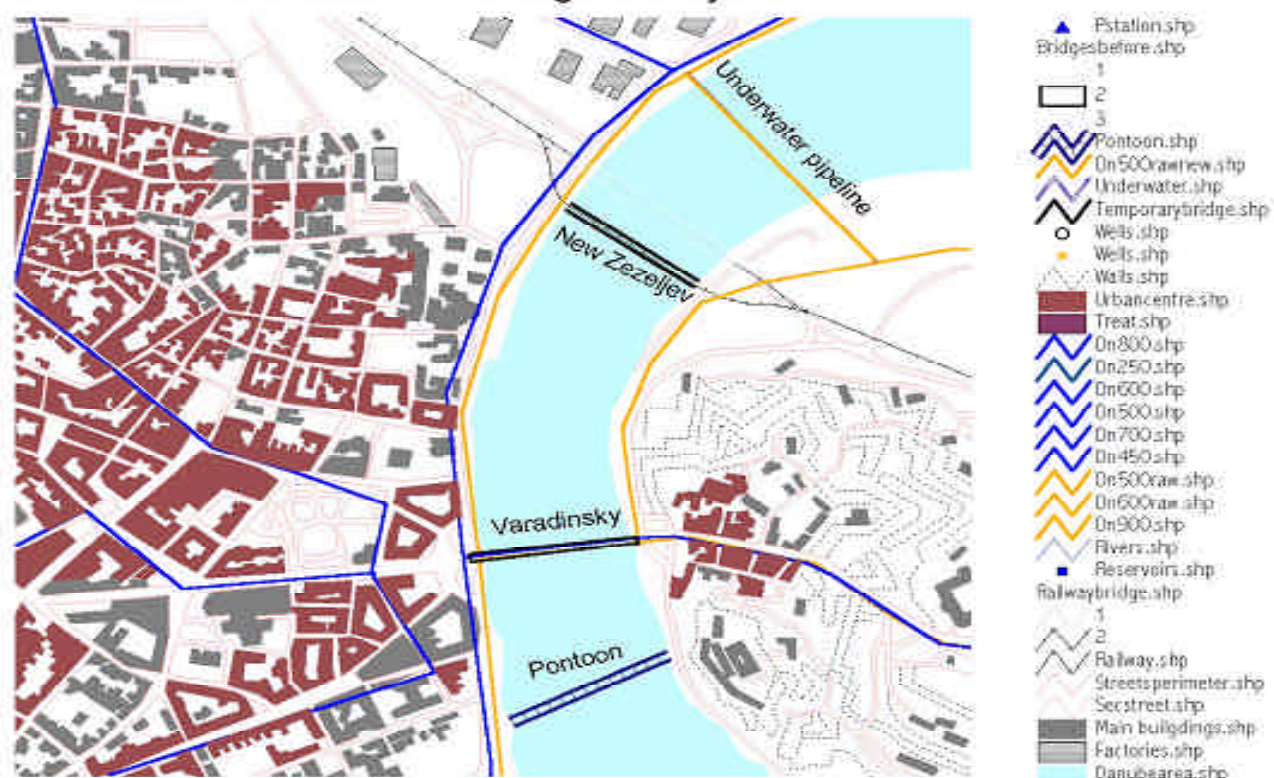
Figure 17

The situation of the bridges and of the main pipelines across the Danube

As long as the bridge farthest upstream is not reconstructed the balancing tank located on the right bank will be out of use. Peaks in demand now have to be addressed with precise management of pumping capacities, but it is clear that the role of this tank will have to be restored. The present reservoir, Transzament, is used to cover the needs of the pumping stations that supply the various localities on the right bank and cannot be converted to a balancing tank for the left bank due to its limited capacity (3000 m<sup>3</sup>).

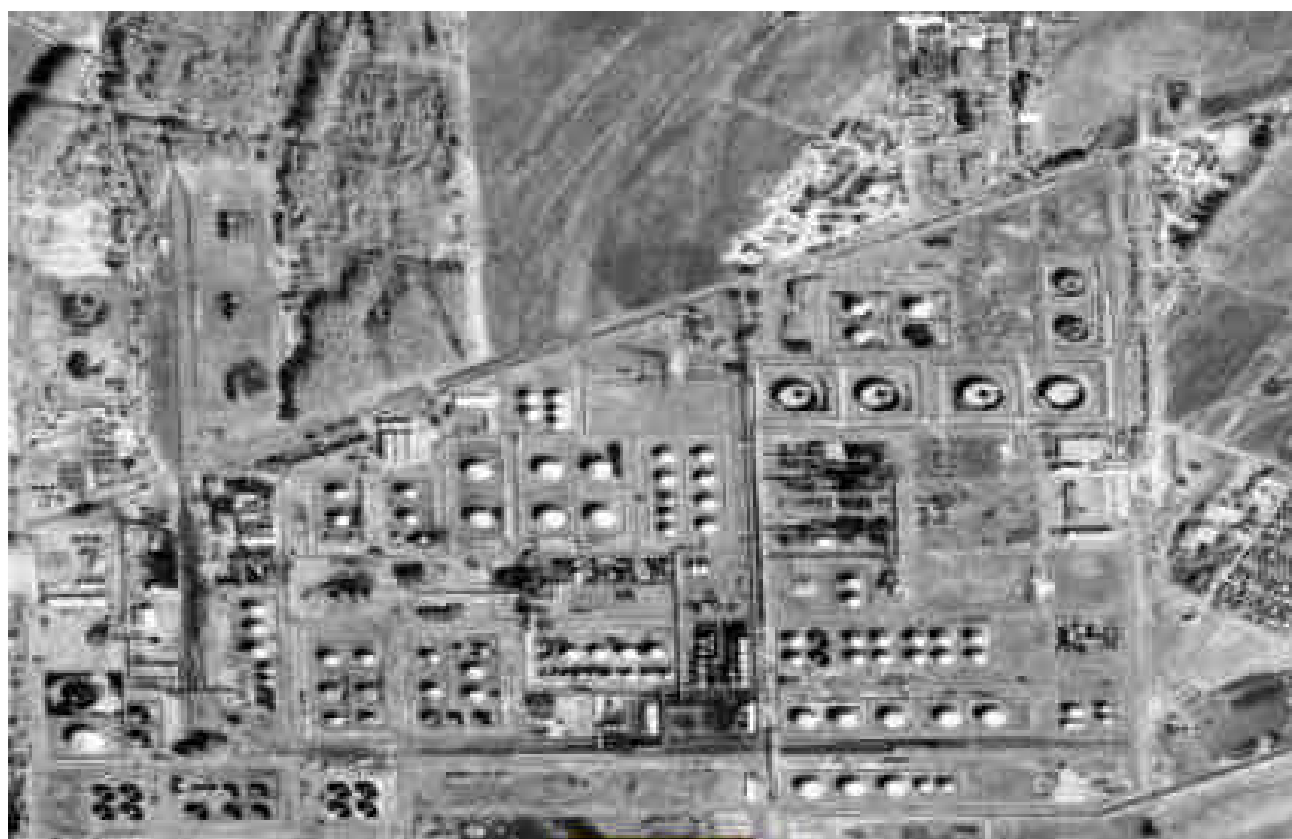
Figure 19  
Aerial view of NIS Novi Sad Refinery (courtesy of Prof. Bozo Dalmacija, Faculty of Science, University of Novi Sad)

The oil refinery of Novi Sad was attacked on several occasions between 5 April and 8 June 1999. More than 250 missiles or bombs hit the refinery facilities, with a total of about 230 during the nights of 2-3 May and 7-8 June. Damage was, of course, considerable and many oil storage tanks were completely destroyed, with a consequent massive leak of oil, hydrocarbons and semi-refined distillate sub-products and huge amounts of aromatic polycyclic-hydrocarbons (PHA). An aerial photograph of the refinery after the attacks, where the damaged tanks can be recognised, is shown in the next figure.

It has been estimated that more than 73,000 MT of oil and oil derivatives were lost. Ninety per cent of these huge quantities burned, causing significant air pollution but 9% were spilled on the grounds of the refinery, where quantities up to 42 g/kg of oil could be collected in ground samplings<sup>6</sup>. About 3,800 MT of crude oil, 480 MT of middle distillates, 4 MT of oil and 60 MT of gasoline were spilled into the ground.

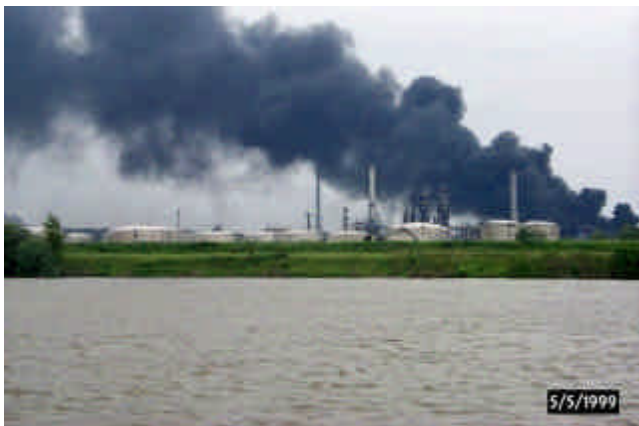
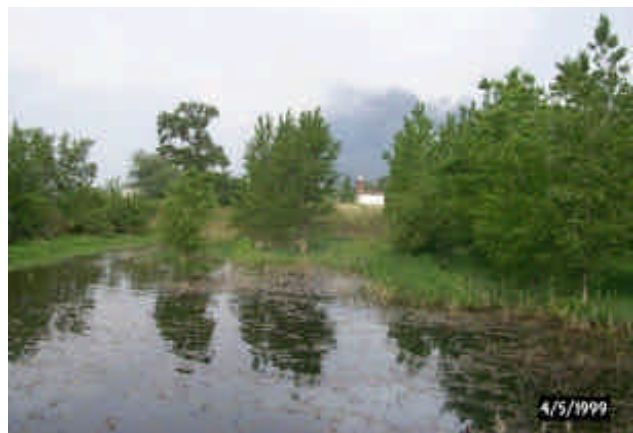
Figure 21  
Air strikes caused heavy damage to the refinery, oil spillage and ground contamination, endangering the water sources located downstream of the pollution point. An oil slick covered the ground over the infiltration wells

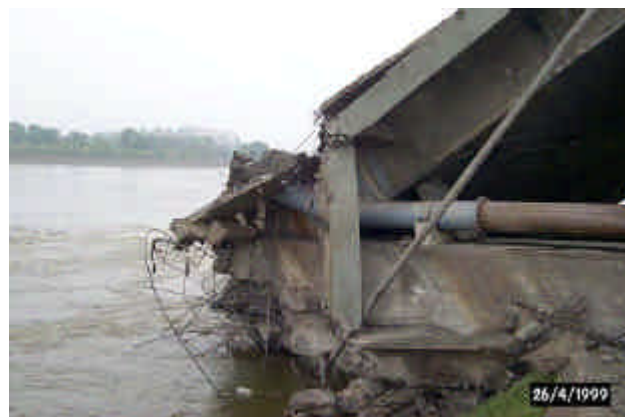
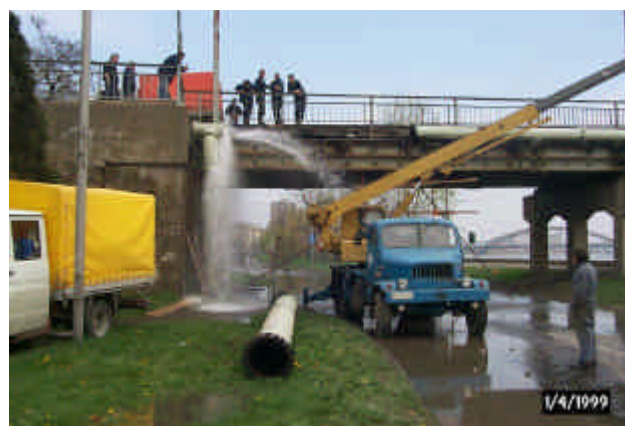
The sequence of destruction is surprising. First the steel bridge was destroyed. This bridge was mainly used to allow small vehicles to cross the river and hosted the pipeline conveying potable water to the right bank. Attempts were immediately made to repair the damage to this bridge, as shown by the following photographs, taken on the day the bridge was destroyed.

But of course nothing could be done to restore to working order the 450 mm pipeline carrying potable water from the treatment station to the right bank. The only solution left to the engineers was to reconnect the 900 mm diameter pipeline conveying drinking water to the balancing tank, located on the right bank. It took them several days to link this line to the distribution network on the right bank, by installing several gate valves. On 6 April, when everything was ready, the Liberty Bridge was destroyed, along with the only remaining pipeline supplying the right bank. Again, a bridge carrying essential conveying lines was targeted and destroyed, thus depriving an estimated 50,000 people of any access to potable water.

*Figure 24 a,b*  
Repairs are carried out after the destruction of the steel bridge (Varadinsky) to stop losses. The 450mm pipeline is out of repair and lies with the steel structure in the Danube

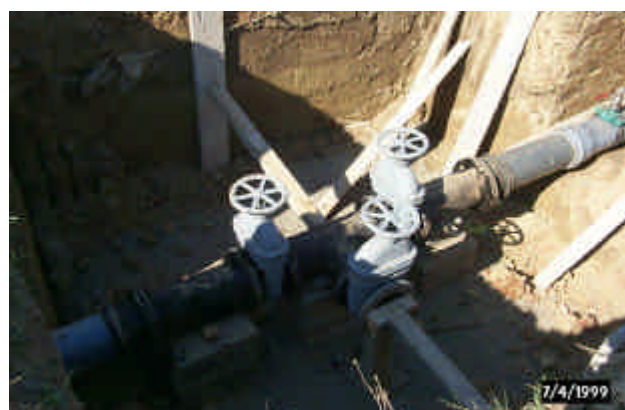
*Figure 25*  
Valves are installed to reconnect the 900mm pipeline to the right bank network

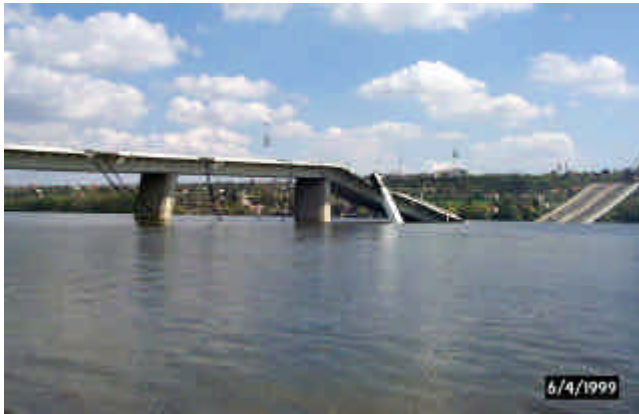
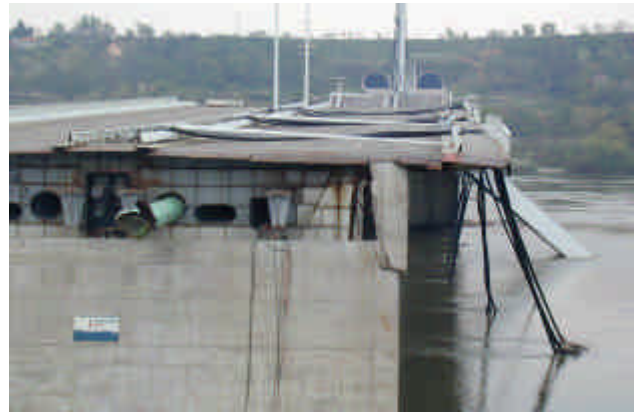
Figure 26 - 27  
The damaged Liberty Bridge and drinking water pipelines conveying water over the Danube

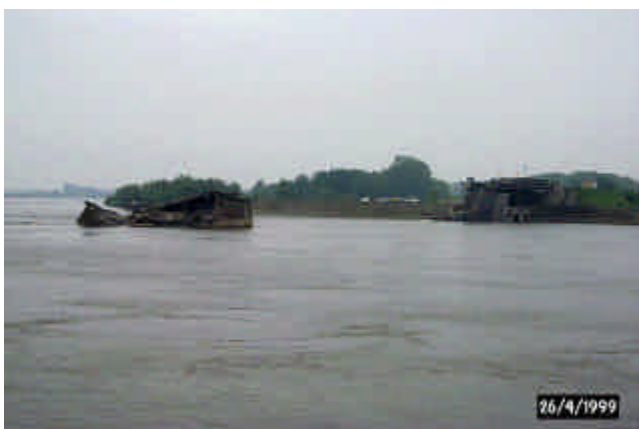
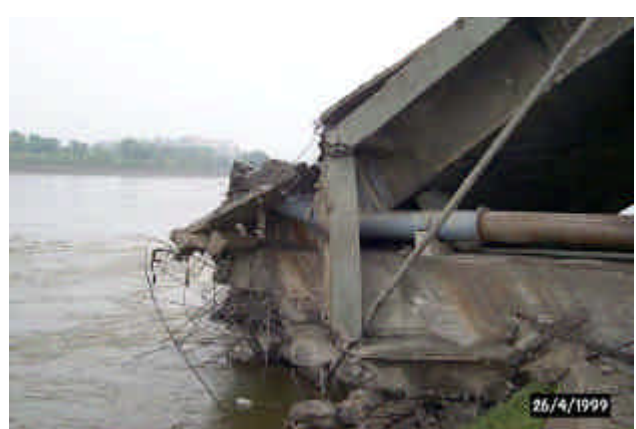
The last remaining bridge, which was used by the railway, resisted longer. Damage to both sides of the bridge rendered it unusable as a means of communication, but it was still possible to repair and reconnect a pipeline previously used to convey raw water. This line would be used, after proper flushing and cleaning, to pump water to the right bank. Almost immediately, construction began on a link between the valve box, located close to the concrete bridge, and the right side of the steel bridge, from where drinking water could be pushed into the elevated storage tank feeding the pumping stations. The line, 1km long and 500mm in diameter, was built in about ten days. All these efforts were reduced to naught when the bridge was again bombed, and destroyed, on 24 April.

Figure 28 - 29  
The destroyed concrete (New Zvezdji) bridge and damaged pipelines

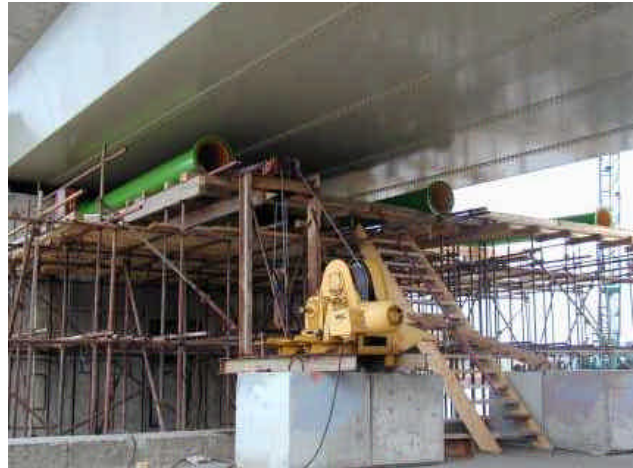
Despite what happened, the decision to install water-conveying lines had to be made and water again flows under this bridge. The underground pipeline, probably built in a hurry and quite vulnerable, has only partially replaced the essential role of a bridge in conveying water across a river.

*Figure 32*  
*Conveying pipelines under the new Varadinsky Bridge*
