The water supply situation of two major towns of Eastern Congo (Democratic Republic of Congo)

P.G.Nembrini¹, N. Capuzzo², G.Allison, M.Serafino², V.Magendo²
L.Wismer², M.A.Mottier, and P.H. Bourlon

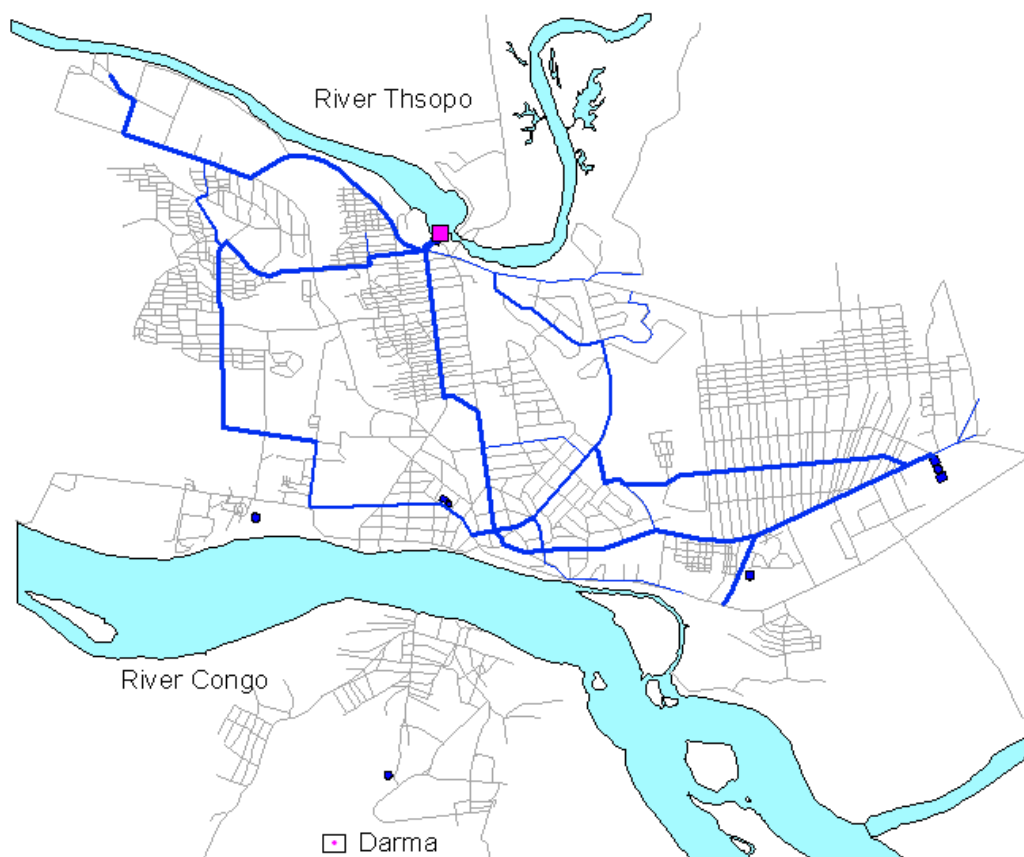
Figure 1 Kisangani Map of the town, of the road grid and location of the 2 water treatment stations, the primary network grid and the main storage reservoirs.

The town is supplied by two stations. The most important one, located on the banks of the river Tshopo, close to the hydropower station, is supplying the right bank of the town. The other, located on the left bank, is distributing water into a smaller network supplying an estimated number of 40-50'000 people. Figure 1 shows a general map of the town with the location of the two plants and the primary network grid.

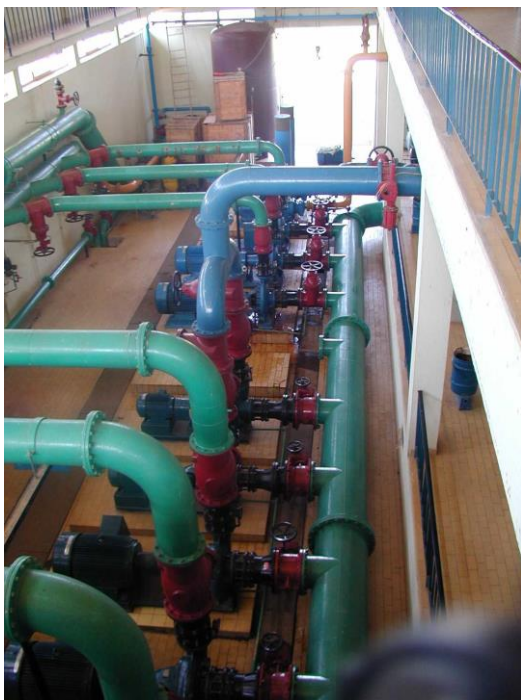
Figure 2 High lift pumps of the new Tshopo treatment station

The main station, was in quite good condition, but has been affected by the last war and by the recent hostilities between the troops located in the town and backed by different foreign countries. The damage, affecting the supply of electricity from the nearby hydropower station, was not too important and could be partially fixed in a few days, with quite brilliant makeshift solutions. But the leakage of the special isolation oil from one of the transformers, damaged by stray bullets, may had important environmental effects, due to the persistence of the specific chemicals in the environment and particularly in the sediments, even if the high flow rate of the Tshopo may have reduced this threat. Damage was considered collateral, due to the specific location of the premises, which were located close to the strategic bridge over the river Tshopo, connecting the town to the northern areas of the province, under control of one faction. Window glasses have been quite extensively broken and were in need to be replaced.

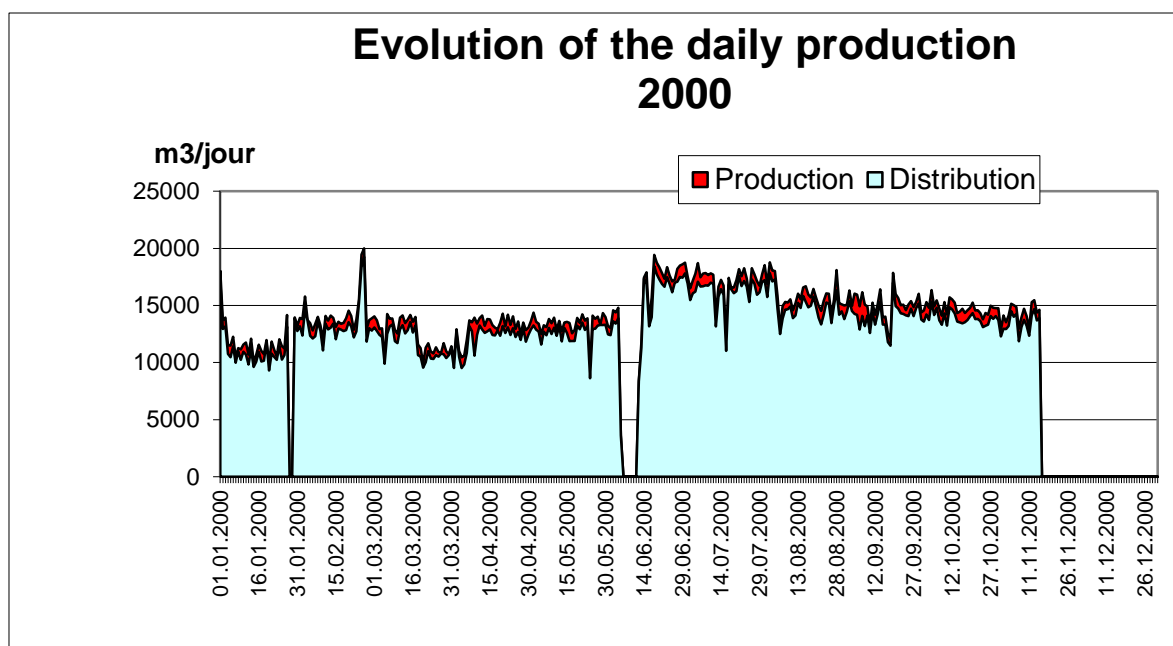
Figure 3 Kisangani WTP : daily production and distribution in 2000 (source REGIDESO)

In fact, it's the availability of power that defines the level of the production. Power is produced by the hydropower station located just nearby. Out of 3 turbines only one was operational, with a maximum production close to 6 MWh, with the station requiring between 1.2 to 1.6 MWh to be operational, that means to produce and to pump into the network. Other consumers were in need of electrical power and the increased demand during the night, linked, among other obvious reasons, to security considerations, did not allow maintaining the station in operation.

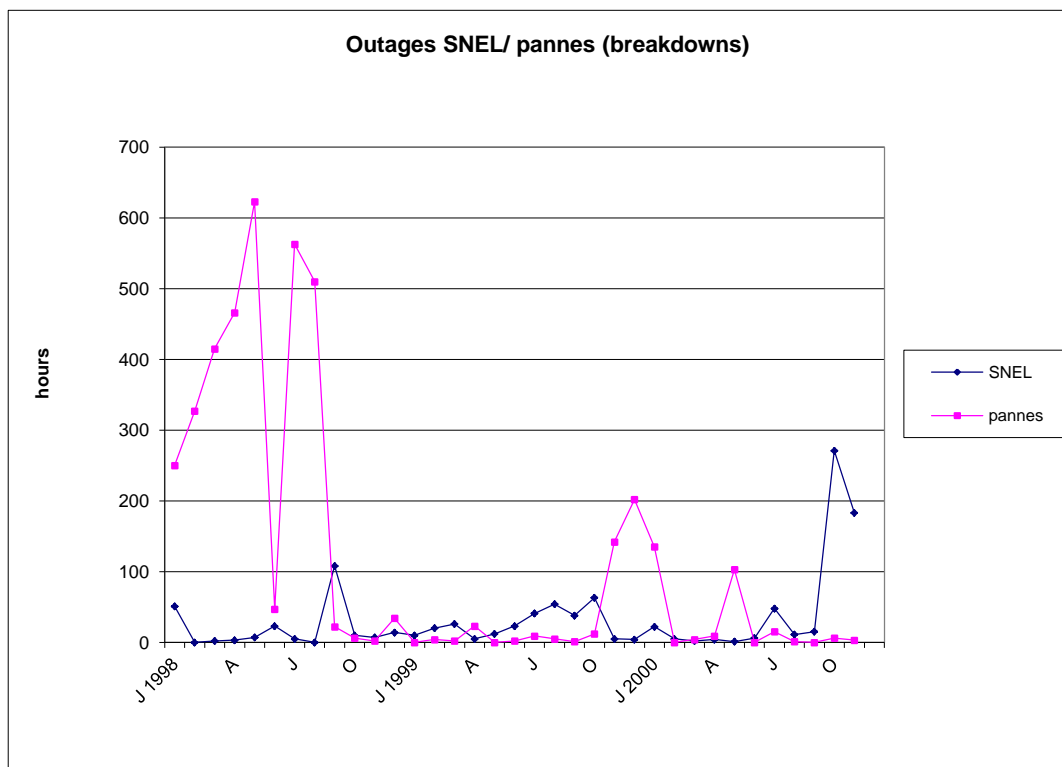
Figure 5 SNEL outages and technical breakdowns at Goma

Production is halted mainly during power outages of the SNEL (Société Nationale d'Electricité) or during some maintenance works. The amounts pumped have increased regularly since 1998 and have reached the average value of 11'000 m³/day (330'000 m³/month). From the following figure (figure 4) it can be seen that the technical failures have been the main reasons for the low output during 1998 with the outages remaining less important. Not all the stations have been affected in the same way, with the main problems observed at the “Turquoise”.

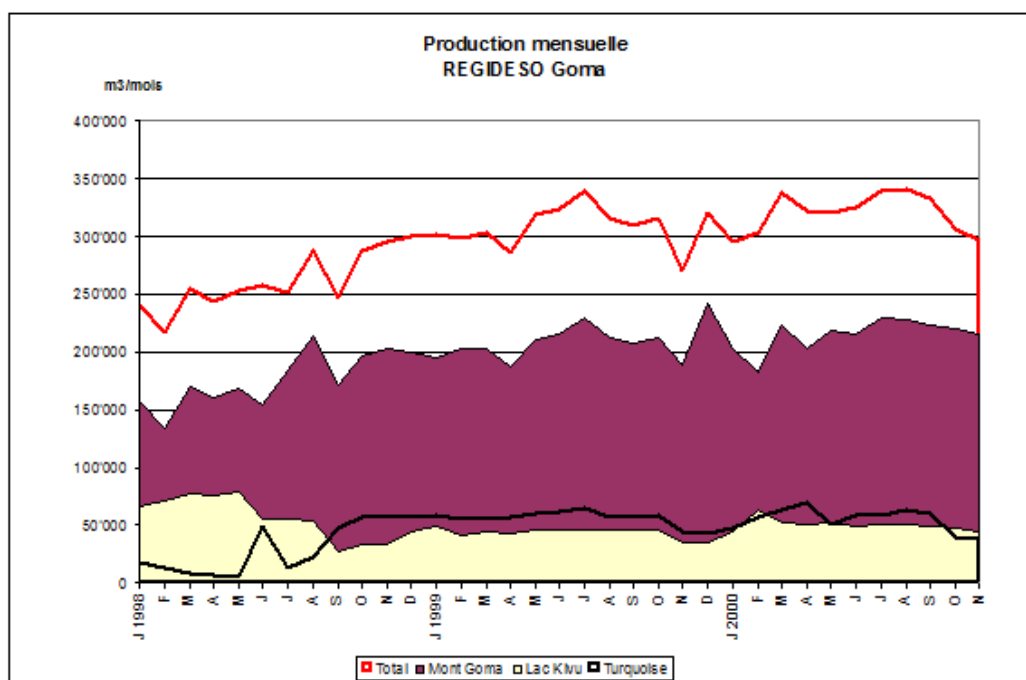
Figure 6 Average monthly production for the Goma pumping stations

In the following figure the evolution of the monthly production from 1998 until 2001 is shown. There are no differences between what is pumped from the lake and what is delivered as nothing is added to the water to remove the turbidity, always below 5 NTU, as it is done when the water is pumped from the rivers. The turbidity increases only after any heavy rainfall, when the incoming streams bring suspended solid to the shores of the lake.

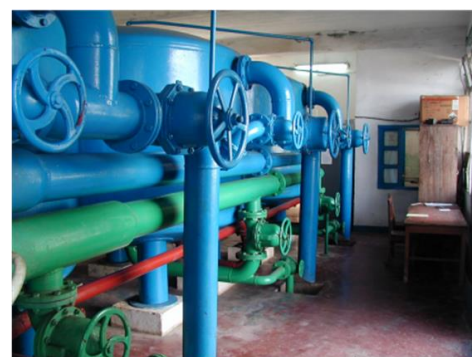
Figure 8 Pressure filters at the Mount Goma station

The ICRC was involved in the financing of the transport of the filtering media for the rapid pressure filters of the station. However the quantity of the sand and to be more precise the effective size (ES) and the degree of uniformity (UD) of the sand grains prepared in Uvira were not as required and some sand was lost, leading to the bypass of the pressure filters. It is unfortunate, as by heavy rains the turbidity of the water at the intake was quite high, and some suspended matter could have been removed if the filters would have been used.

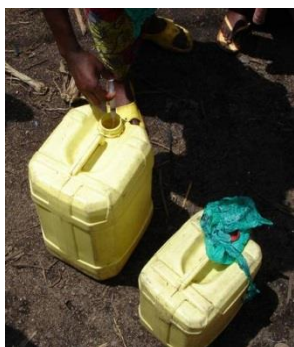
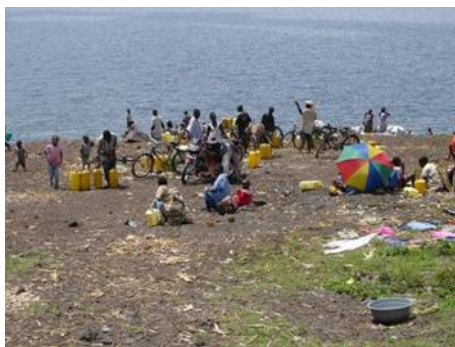
Figure 12 Chlorination of the jerry-cans and people fetching water at lake Kivu

arrival. The pumps installed by OXFAM to supply the camp of Kibumba (population in 1998 estimated to 20'000) with chlorinated water were lately removed and installed in 1998-2000 at the lake Kivu station, to strengthen its pumping capacity.

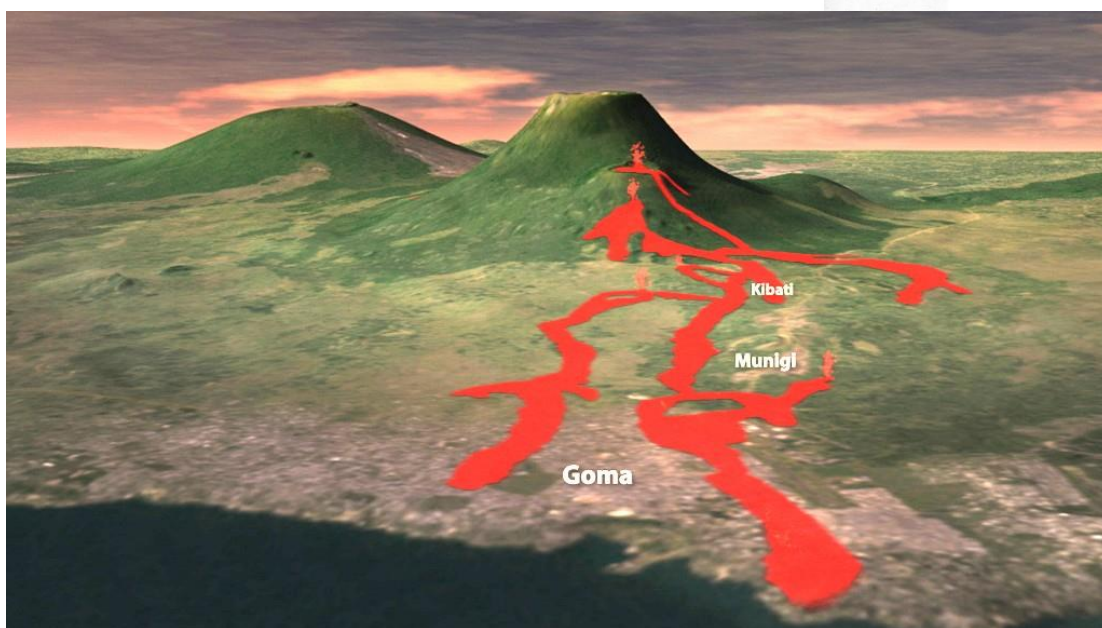
Figure 13 Network and area affected by the lava

The lines supplying the Eastern part of the town were damaged. Only one distribution line was re-established. The problem of the massive relocation of the population toward the Western bounds of the town had to be addressed. The chlorination of the water collected directly at the lake was resumed and increased. The Keshero (Sotraki) pumping station was made operational and the line distributing water to Himbi, Keshero, Ndosho was re-enforced with a galvanised iron pipeline of 200, respectively 150 mm of diameter. The proposals of the IGIP study were reconsidered and a new study to modelise the network was undertaken.

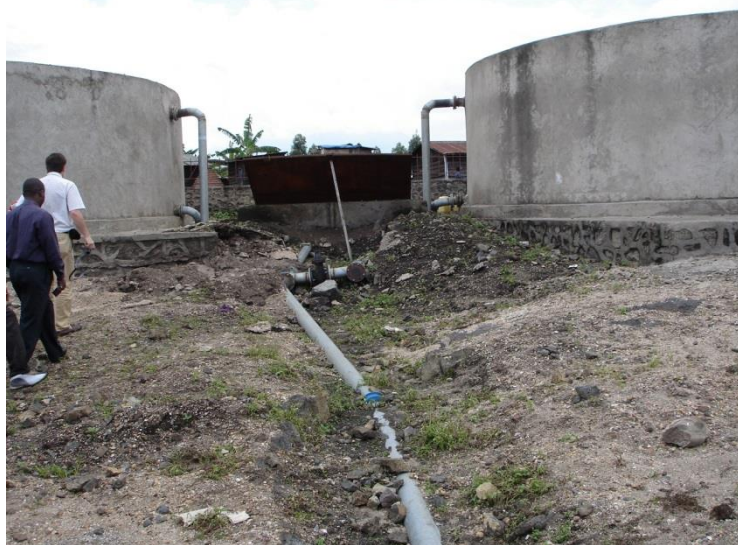
Figure 14 New reservoirs built East of Mt. Goma

A joint project with the REGIDESO was implemented to allow supplying the new urbanised areas from the Keshero pumping station. Two storage reservoirs of 200 m³ each were built in the highest area of Ndosho and plans were drawn to re-build the pumping station and to replace the already re-enforced pipeline, on which many new connections were made. Its diameter was already too small to supply the reservoirs and a new line had to be installed. Early 2005 the reservoirs were completed but the final design of the pumping station was not yet approved by the technical department of the REGIDESO headquarters, with the consequent delay of the implementation by the ICRC. The new pipes of 300 mm of diameter, to be transported from Bukavu and from Uvira under the responsibility of the utility, were not yet available and were anyway not sufficient to cover the whole distance. The remaining length, of about 3 km, would have to be purchased under the PUSPRESS programme of the World Bank. After an initial study carried out by a consulting firm, a consortium of other consultants named MODRU was charged to hire a consultant to carry out the final tender document for the rehabilitation of the network and of the pumping stations, almost two years after the initial commitment of the funds.
